STATIC NUMERIC AND EXPERIMENTAL ANALYSIS OF
PREFABRICATED WINDER WOODEN STAIRCASE WITH
CENTRAL STRINGER MADE FROM SCOTS PINE
(*PINUS SYLVESTRIS L.*)

MILOŠ LAVICKÝ, JAN PĚNČÍK, JAKUB DOHNAL, DAVID BEČKOVSKÝ
TEREZA BEČKOVSKÁ
BRNO UNIVERSITY OF TECHNOLOGY, FACULTY OF CIVIL ENGINEERING
INSTITUTE OF BUILDING STRUCTURES
BRNO, CZECH REPUBLIC

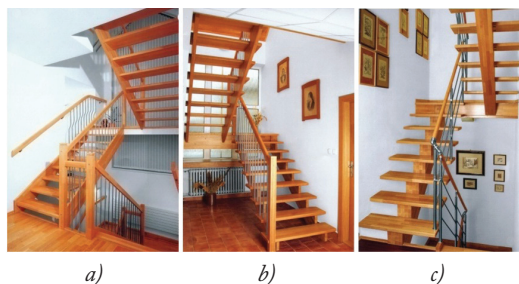
Fig. 1: Wooden prefabricated staircase with two outside straight stringers a), b) and wooden prefabricated staircase with a central straight stringer c) (JEMA Svitavy 2006).

One of the staircase types that meets these requirements while at the same time becoming a dominant architecture element is a prefabricated wooden staircase in different construction arrangement. The group of these staircases includes prefabricated staircases with one-sided suspended stairs with or without a stringer. Numeric analyses and experimental tests including subsequent modification of the staircase structure with one-sided suspended stairs without stringer are described in Pěňčík et al. (2015). Pěňčík (2015) deals with a detail of support of stairs of this type of staircase. Furthermore, this group includes a prefabricated spiral staircase with or without stringer. This type of staircase was numerically and experimentally tested by Pousette (2003). In addition, Pousette (2006) deals with the testing and modelling of the behaviour of wooden stairs and stair joints for prefabricated stringer staircases with two outside straight stringers (Fig. 1a,b). Another special type of prefabricated stringer staircases is a staircase with a central stringer, where the stairs are supported by a stringer or by another way, e.g. a pair of diagonal steel struts. In the majority of cases this type of staircases is designed with a straight stringer. This article deals with a description, numeric, static and experimental analysis of a special ground plan arrangement, where prefabricated stringer staircase with a central winder stringer (Figs. 2, 6) is used to overcome different height levels.

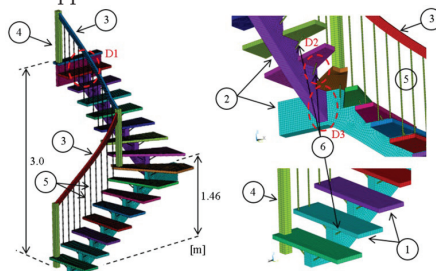
Fig. 2: 3D analysis model in software ANSYS (2011) – 1) stair, 2) stringer, 3) massive handrail, 4) column, 5) system of steel bars, 6) diagonal steel strut.

Regarding the detected increased level of stresses at stringers the detailed behaviour analysis was performed with the use of software ANSYS (2011) and 3D analysis model. The analysis model showed in (Fig. 2) was created with the use of 3D finite elements of types BEAM188, SHELL181 and SURF154, and described in detail in software ANSYS (2011a). The method of modelling of individual staircase parts was similar to the modelling of prefabricated staircases with one-sided suspended stairs described in Pěncík et al. (2015). The boundary conditions were considered based on the real support conditions.

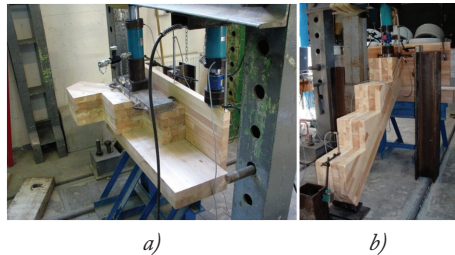
Fig. 3: Test D1: loading by torsion moment a) and shear force b).

In the test (D1) three specimens at the connection of the stringer thickness of 0.2 and height of 0.35 m with 3 cut-out segments for stairs 0.25 wide and 0.187 m high and the front board with dimensions of 1.0 × 0.34 m and thickness of 0.04 m at the initial stair were tested for loading by torsion moment. The connection of the stringer and the front board was made by 4 wood screws \varnothing 8/80 mm in combination with 4 oak dowels \varnothing 16 mm. (Fig. 3a) shows the arrangement of the test. The position of the stringer on the testing bench was secured by the pressure of 2.5 kN by a hydraulic press. Torsion moment was produced by another hydraulic press KGF U25-150, which

The same connection of the stringer and the front board was also loaded by a shear force. The stringer has an inclination of 37° . The arrangement of the test is shown in (Fig. 3b).

The connection of the stringer 0.2 thick and 0.35 m high with 4 cut-out segments for stairs 0.25 wide and 0.187 m high with the front board with dimensions of 1.0×0.34 m and thickness of 0.04 m was performed in the same way as when loaded by torsion moment, i.e. the connection was made by 4 wood screws $\varnothing 8/80$ mm and 4 oak dowels $\varnothing 16$ mm. Three specimens, consisting of a part of the stringer and the front board, were mounted during the tests so that the additional board was by its bottom surface fully placed and supported on the support bench. The bottom part of the stringer was placed on a board to establish a simple support. The loading was applied by a hydraulic press KGF U25-150 which was fixed to the support frame of the testing bench in the centre of the stringer. The applied force was recorded by a tensometric dynamometer CSP-M-25t-C3-SC-SS put in between the hydraulic press and the highest edge of the stringer right at the front board, so that the bending moment was as low as possible. The tests were terminated once the failure of the connection of the stringer and the front board occurred.

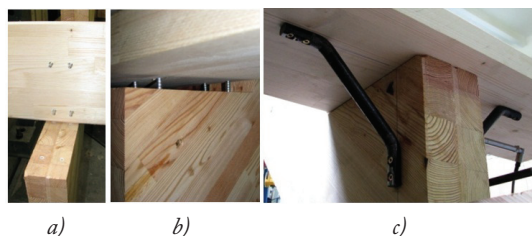
Fig. 5: Views of the connection of the stair to stringer with plastic wall plugs inserted to the stringer a) and steel struts put inside wall plugs b) and support of the stair by steel struts c).

The bottom and top part of the stringer was placed on a board or frame to establish the simple support. During the testing the stair was placed on the upper part of the stringer and was connected to the stringer by plastic wall plugs inserted in the stringer and steel struts that were put inside of the wall plugs (Fig. 5a, b). The stair was further supported by a pair of steel struts with $\varnothing 16$ mm, which were connected to the bottom surface of the stair and side parts of the stringer with 4 wood screws $\varnothing 5/40$ mm (Fig. 5c). The loading was applied by steel loading boards of known weight, which were placed at the stair edge in the distance of 0.44 m from the stringer centre in order to reach maximum loading of the connection. The loading was performed in 9, or 10, loading steps with the intensity of loading reaching 0.36 – 0.50 – 0.61 – 0.71 – 0.82 – 0.93 – 1.04 – 1.14 – 1.45 (potentially also 1.65 kN). The testing was terminated once the failure of the connection of the stair to the stringer occurred.

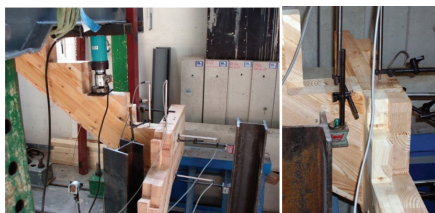
Fig. 6: Test D3.

During the test (D3) three specimens of the connection of two left-turn winder stringers with the inclination of 37° , thickness of 0.1 and height of 0.35 m with segments for stairs for shear. The lower stringer consisted of 4 cut-out segments for stairs 0.25 wide and 0.187 m high, and the upper stringer consisted of 5 cut-out segments for stairs 0.25 wide and 0.187 m high. The construction height of the staircase was 1.82 m. The arrangement of the test is shown in (Fig. 6).

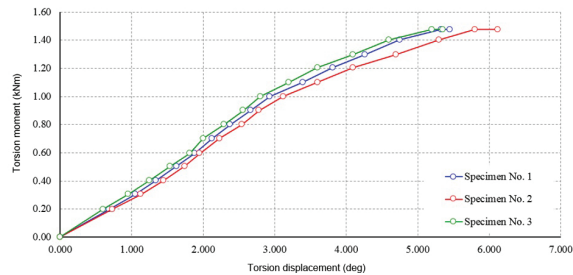
Fig. 8: Graph of relationship between torsion displacement (rotation) and applied torsion moment.

The failure of the stringer and front board connection at the last stair under the effects of torsion moment occurred at the use of average ultimate force 3.28 kN, which corresponds with the average torsion moment of 1.48 kNm. All three tests were terminated for safety reasons due to excessive turning of the front board. The effect of extreme force caused turning of the tested specimens of the front board up to by 5.35° to 6.12° in comparison with the initial condition. The graphic relationship between torsion displacement (rotation) and applied torsion moment is shown in (Fig. 8).

The courses also show that in the initial loading phase the linear relationship between the torsion displacement and applied torsion moment is valid. In addition, the courses show that the pushing of oak dowels \varnothing 16 mm and beginning of wood screws occurred once torsion moment reached 1.0 kNm. The view of the front stringer surface, which was in contact with the front board with partially pulled out wood screws and pushed oak dowels \varnothing 16 mm to the stringer, is shown in (Fig. 9a). The view of partially turned front board after one of the tests is shown in (Fig. 9b).

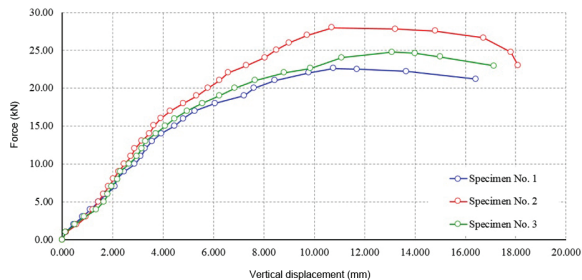
Fig. 10: Graph of relationship between vertical displacements to applied force.

10.76, 10.71 and 13.10 mm). The graphic relationship between stringer vertical displacement and applied force is shown in (Fig. 10).

The graphic relationship shows that in the initial loading phase the linear relationship between the vertical displacement and applied load is valid. Non-linear behaviour caused by gradual failure of the connection, i.e. loosening of wood screws and pushing of oak dowels \varnothing 16 mm to the stringer, or the front board respectively, is obvious once the loading reaches approx. 15 kN. The view of the failed connection with a detail of partially pulled up wood screws and pushed oak dowels \varnothing 16 mm to the stringer, or the front board respectively, is shown in (Fig. 11). One dowel was broken during one of the tests.

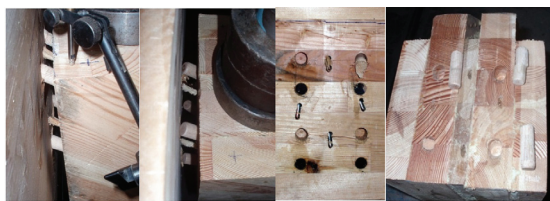
Fig. 11: Failed connection with a detail of partially pulled up wood screws and pushed oak dowels \varnothing 16 mm to the stringer and the front board.

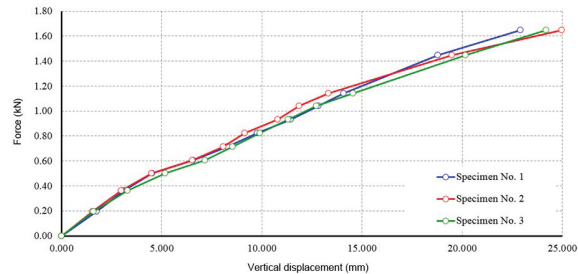
Fig. 13: Graph of relationship between vertical displacement and applied force.

The material of inserted wall plugs was deformed (Fig. 12c). During the testing of all specimens and under the loading of 0.50 kN the connection of the stair and stringer began to split up (Fig. 12a), which is also obvious in the change of loading curve course (Fig. 13). Under the loading of 1.65 kN average vertical displacement by 24.03 mm of the loaded stair part occurred.

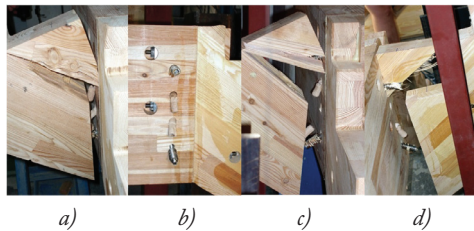
Fig. 14: View of failed stringers connection.

In the test (D3) three specimens of connection of two left-turn winder stringers were tested. The tests of all three specimens were terminated only when the connection was fully broken, as shown in (Fig. 14).

The upper stringer split up in the connection for all specimens. At the same time the inserted anchoring nuts to anchor threaded rods were torn out of the upper stringer. The connection failure occurred under the average force of 33.23 kN. The effect of this amount of loading caused an average displacement difference of stringers by 8.79 mm. An average vertical displacement by 6.66 mm occurred in the middle of the upper stringer.

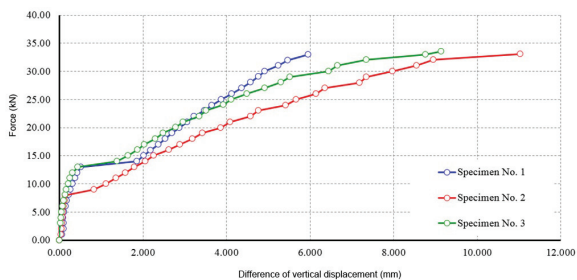
Fig. 15: Graph of relationship between differences of vertical displacements of stringers in the stringers connection to applied force.

The graphic relationship between the differences of vertical displacement of stringers in the stringers connection to the applied force is shown in (Fig. 15). The dependence courses show the linear dependence in the initial phase between the amount of applied load and the difference in stringers vertical displacement in the stringers connection. Once the initial connection failed under the loading of approx. 10 kN, the dependence became non-linear (Fig. 15).
